Lifetime Durability of Ceramic PX™ Energy Recovery Devices

Energy Recovery Inc

September 2011

A White Paper on Long Life Materials for
Desalination Applications

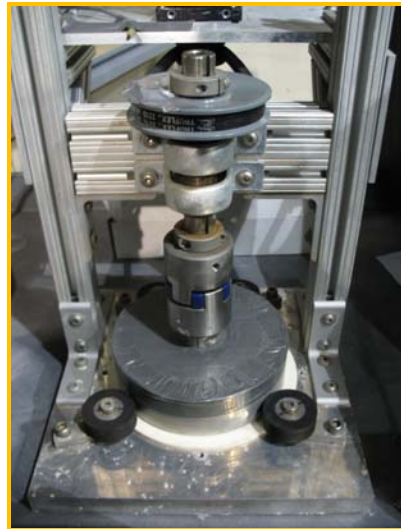
FIGURE 2. ERI Submersible “Pin on disk” Ceramic wear testing apparatus

ERI™ engineering regularly evaluates used components for physical wear. To complement this data, ERI developed materials testing capabilities. To date, quantifying the measure of wear of ERI ceramics using this test generates results that are undetectable; even when operated at almost 10 times the designed thrust load applied to the PX unit. ERI has been unable to quantify wear rates on ERI ceramics using this test since wear channels generated are within the limits of ERI test metrology; even when operated at almost 10 times the designed thrust load applied to the PX unit.

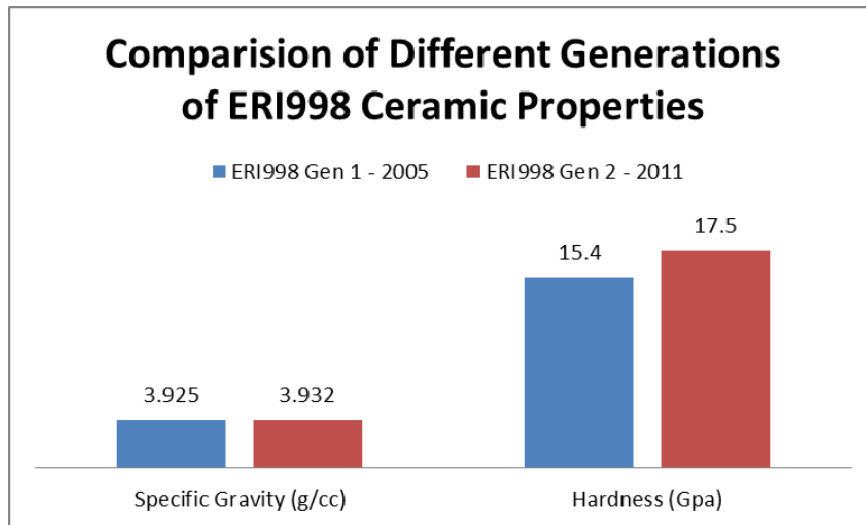
FIGURE 4. The current generation ERI998 ceramic has improved considerably over previous generations and is now produced at the San Leandro facility in California.

Recent developments in ERI material science efforts indicate that the new formulation has further improved performance. The data in Table 2 and Figure 4 depicts specific improvements made to ERI ceramics. The newly formulated ERI998 Gen 2 is being launched with a new and improved PX device called the PX-Q300.
